Manhole Inspection Summary

Manhole # S25MM_029MH

Insp Date: **8/7/07 8:39 AM**

Location Address: **2417 MORRIS ST**

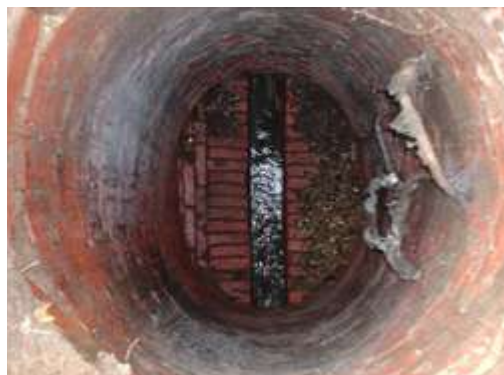
Top View

Corroded steps. Evidence of surcharge - Bench debris.

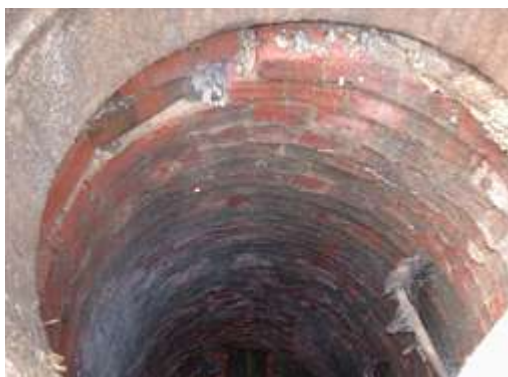
Defect

Frame leaks. Adjustment deterioration, loose brick and infiltration. Corbel and Barrel infiltration - other side.

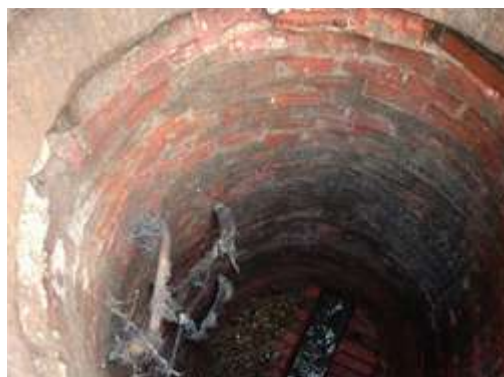
Defect

Frame leaks. Adjustment deterioration, loose brick and infiltration. Corbel and Barrel infiltration.

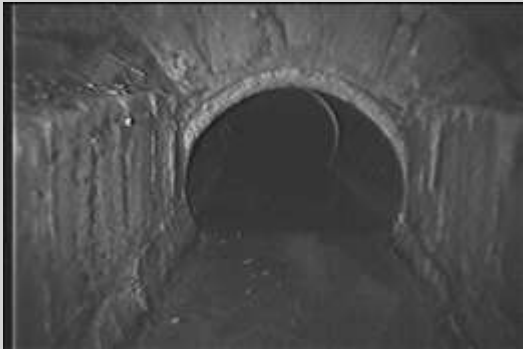
8 in. Circular Gravity Sewer Pipe Out @ 12 O'Clock

Pipe Material: **Clay** ☐ Pipe Lined

Invert Depth: **9.85** (ft.) Flow Characteristics: **Fast**

Deposits: ☒ None ☐ Mud ☐ Sludge ☐ Debris ☐ Grease

Infiltration: **None** Pipe Seal Cond: **Unknown**

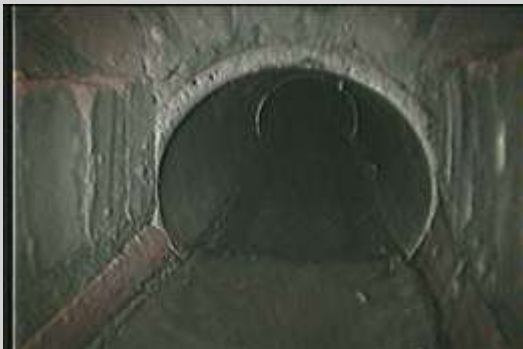
8 in. Circular Gravity Sewer Pipe In @ 6 O'Clock

Pipe Material: **Clay** ☐ Pipe Lined

Invert Depth: **9.80** (ft.) Flow Characteristics: **Fast**

Deposits: ☒ None ☐ Mud ☐ Sludge ☐ Debris ☐ Grease

Infiltration: **None** Pipe Seal Cond: **Unknown**
